**FINAL PROJECT REPORT
FOR THE
PALM BEACH COUNTY
2007 HABITAT MAPPING PROJECT**

**Prepared under Task Order 0688-01A
by:**

**Avineon Inc.
15500 Lightwave Drive, Suite 200
Clearwater, FL 33760
Tel (727) 539-1661**

Report Date: 6/30/08

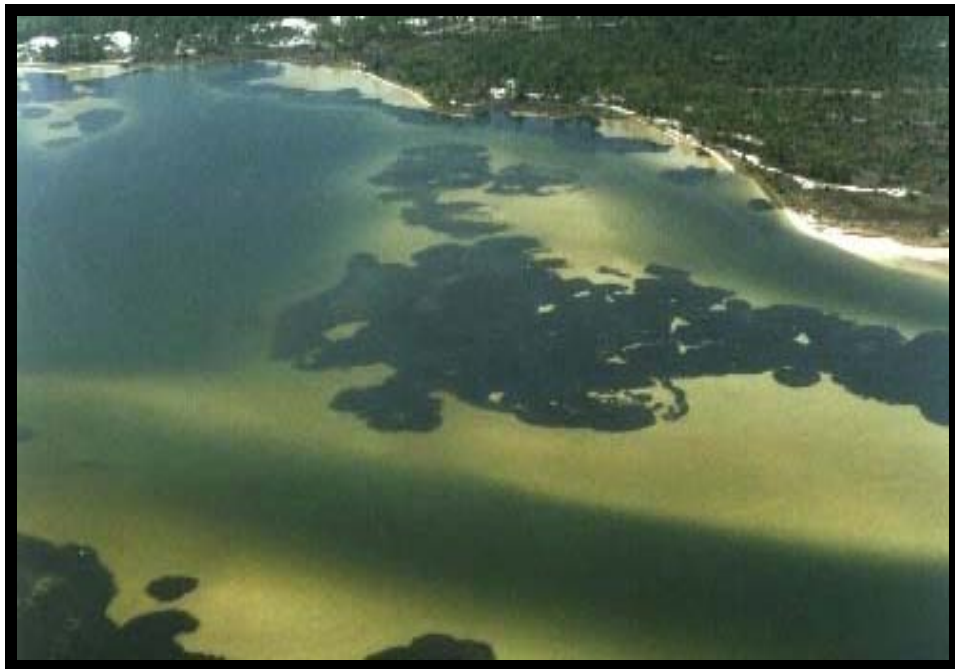
9116 Continuous Seagrass

The photosignature for 9116 is smoother than that of 9113 but still has some texture. It also can be bluish-gray to almost black, but has only a few areas of open bottom showing through to interrupt the continuous signature. 9116 usually can be found in the center of large, healthy seagrass beds and sometimes runs parallel to the shoreline for hundreds of meters. These larger beds usually have some sparse growth between the continuous areas (i.e. they are not always composed of a uniform thickness, but are still considered continuous).

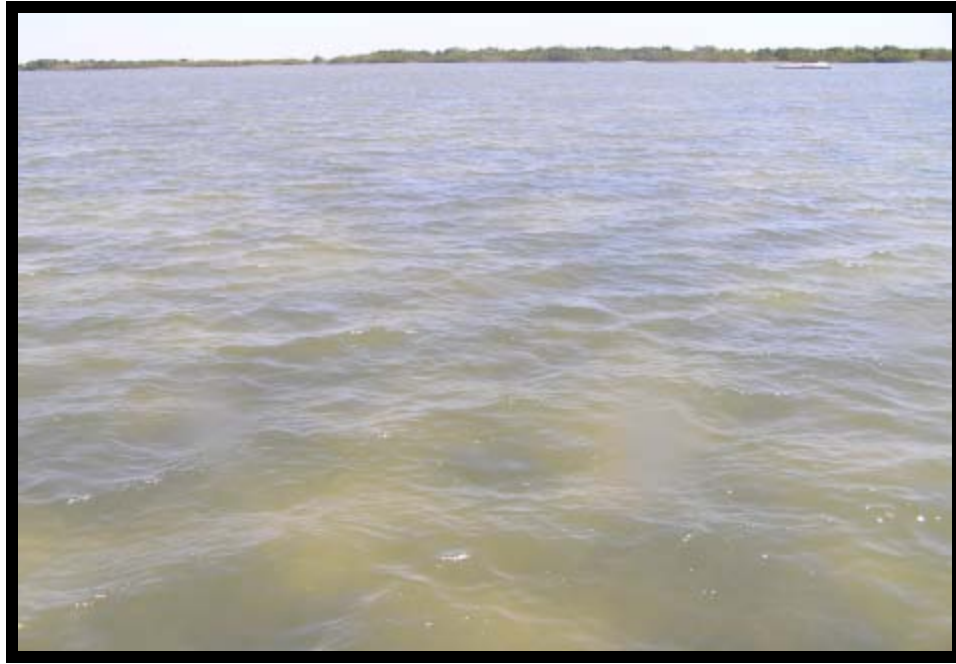
9113 Patchy seagrass

The photosignature for the 9113 classification usually has a rough texture when viewed through a stereoscope and is bluish-gray to almost black depending on water depth and

turbidity. Patchy seagrass polygons can be found on the deeper and shallower edges of continuous seagrass beds or can be large and expansive and cover the entire bed. The actual seagrass beds will look like small circular colonies that are close enough together to be combined into a seagrass polygon. These areas can occur because of new growth on a previously unvegetated substrate, or within areas of previously continuous seagrass that is deteriorating due to changing water conditions such as salinity, turbidity, and temperature or pollution levels.

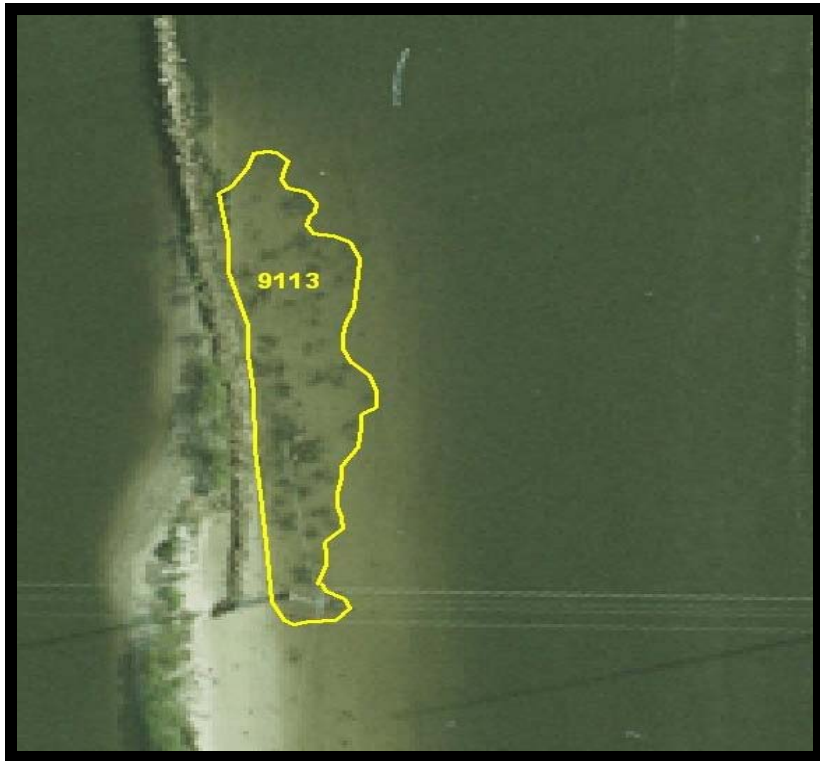
Delineated photograph showing 9113

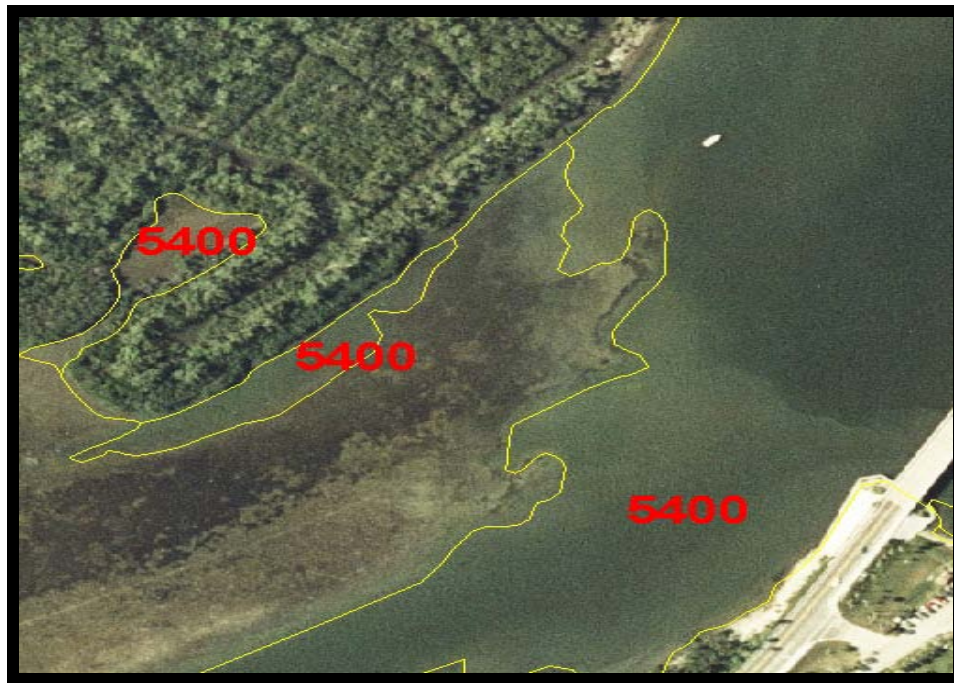
Delineated photograph showing 5400

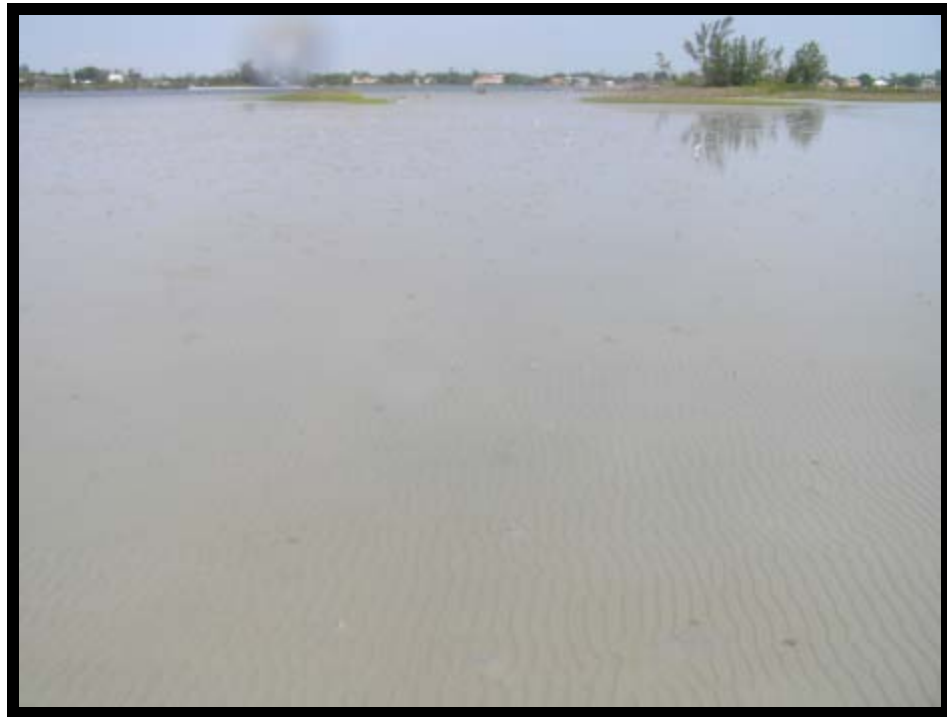
6510 (Tidal Flat)

The photo signature for 6510 is very smooth and obviously unvegetated. The signature can be different colors depending on water depth and turbidity levels. It can appear white (very shallow, sandy areas), light green (deeper, sandy areas), gray (murky water), or even light brown in some tannin-stained areas. 6510 is usually found on the shallower edges of seagrass beds, either along the shoreline or on the crest of a barrier-type seagrass bed

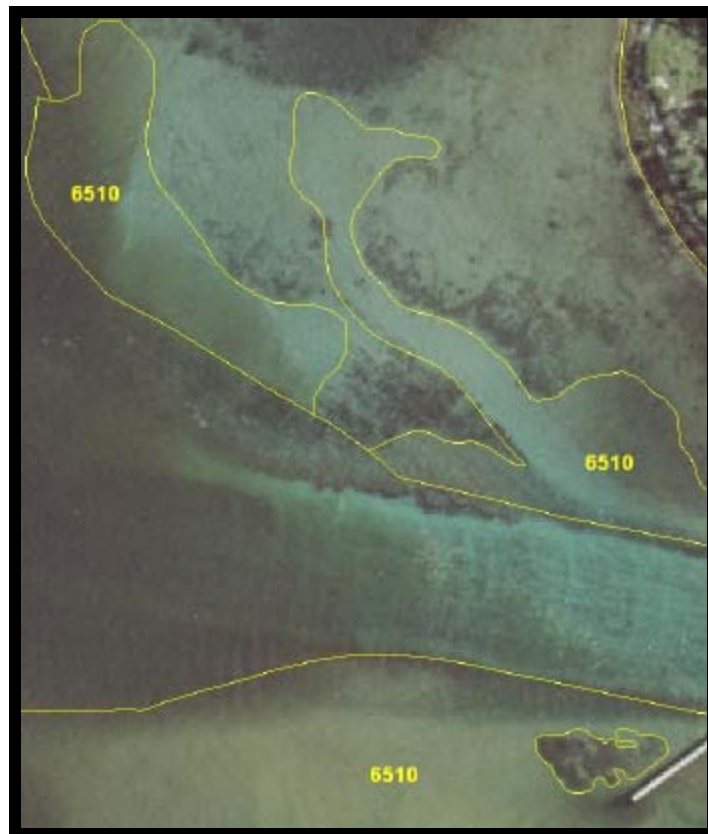
Delineated photograph showing 6510

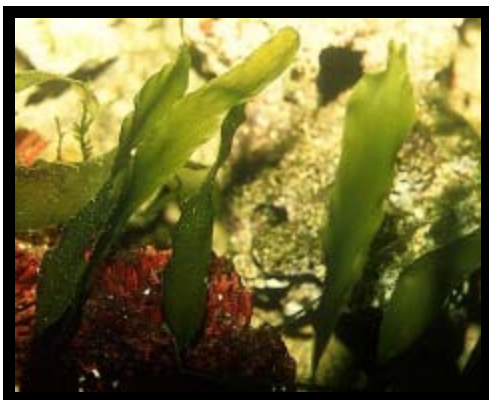
9121 *Caulerpa prolifera*

The photosignature for the 9121 classification is very similar to that of the patchy and continuous seagrass beds. It exhibits the same bluish-gray color and can have either a rough or smooth texture depending upon the amount and thickness of the algae present. Algae beds can consist of either attached algae or drift algae. The attached algae photosignature is exactly the same as that of seagrass and can only be differentiated through field reconnaissance. On the other hand, the drift algae can usually be found in clumps and windrows (chevron shaped accumulations) that have been affected by the current. It is usually found spread out over large, flat areas (which are on the deeper edges of the seagrass beds), or in thick accumulations that are clumped together against some type of current blocking structure (i.e. spoil islands or channel edges). It is also identifiable by depth (anything deeper than 2 meters is probably algae).

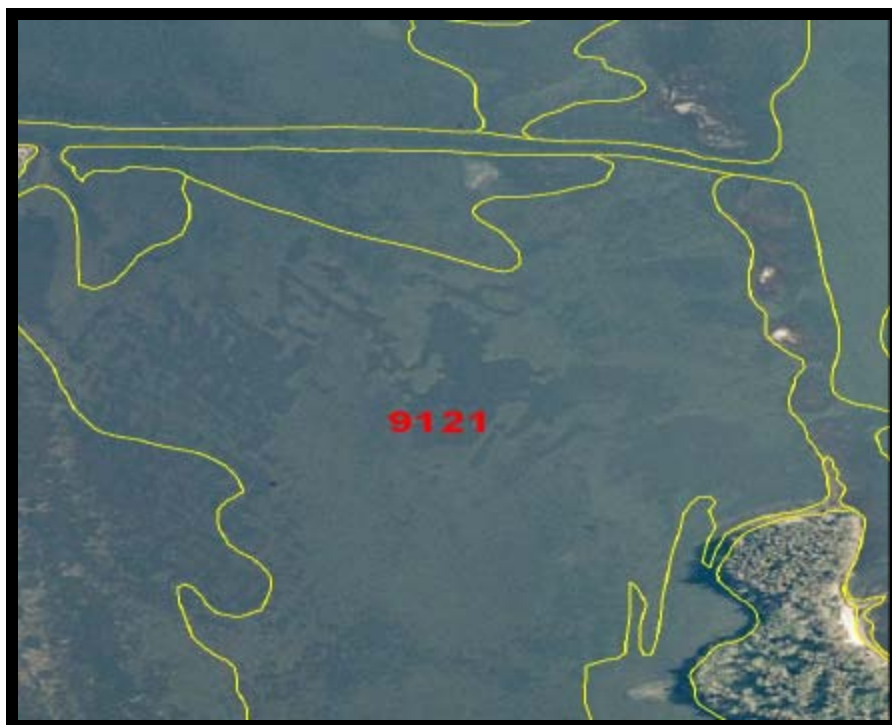
Delineated photograph showing 9121

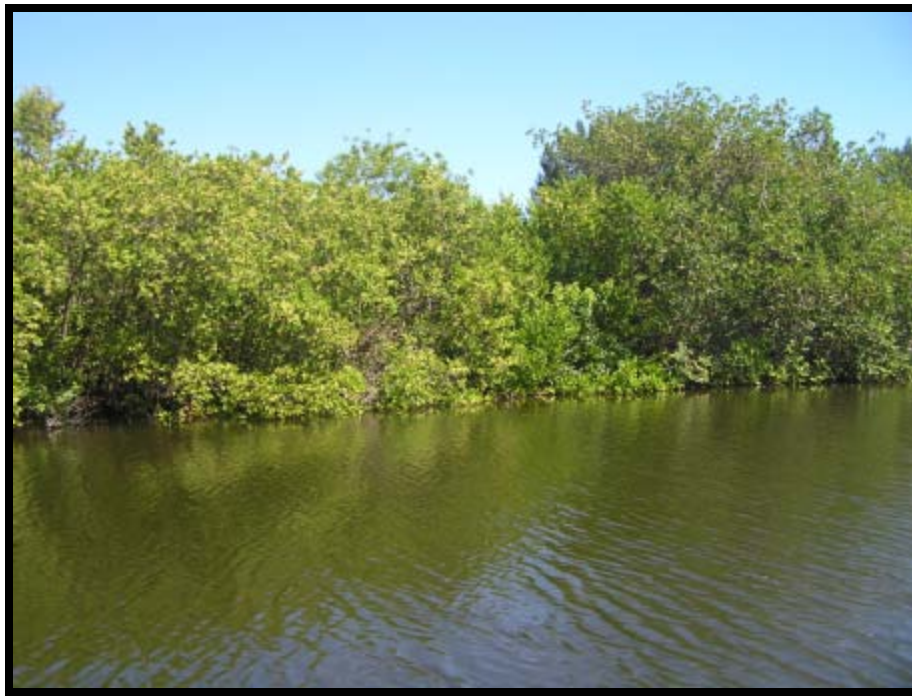
6120 Mangrove Swamp

Primarily found in, but not limited to, coastal areas subject to periodic or continual inundation by salt or brackish water. Red mangroves extend to the open water, with black mangroves towards the landward edge, and white mangrove in the most landward, least inundated.

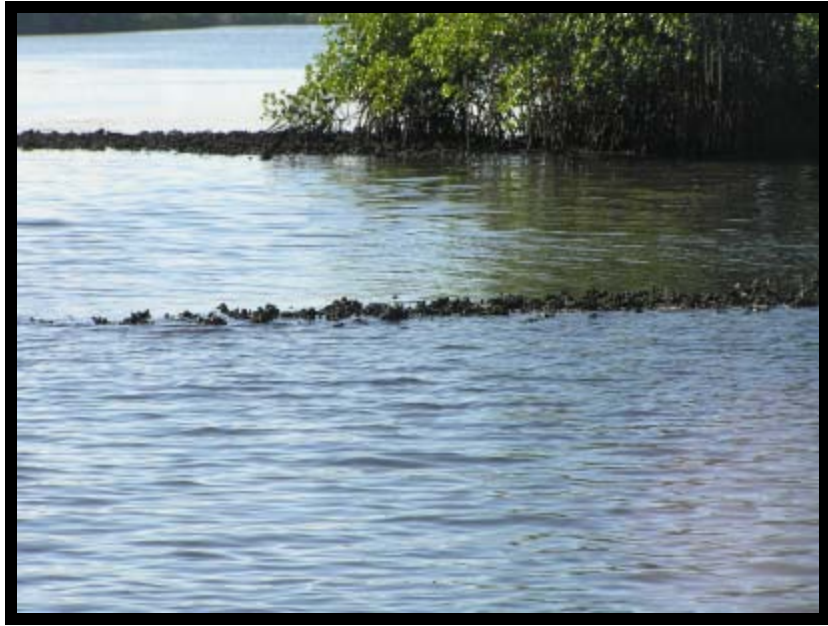
6540 Oyster Bars / Reef

The photo signature for 6540 is bright white to light gray with a distinctive ridge often visible when the beds are exposed at the surface. The beds can also appear dark gray to black in color when algae are growing or have accumulated on the shells. The texture of submerged oyster beds is mottled in appearance when viewed in stereo while exposed beds are smooth in texture. 6540 is usually found in shallow brackish water creeks (10% salinity or more), flats, and near docks and jetties.

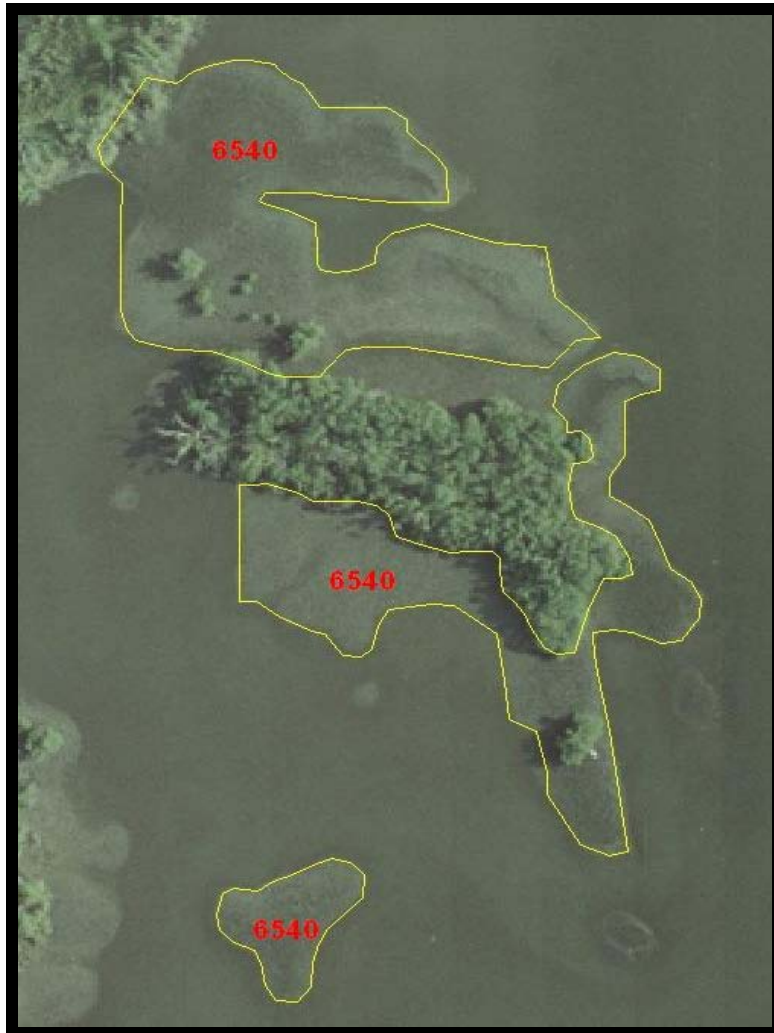
Delineated photograph showing 6540

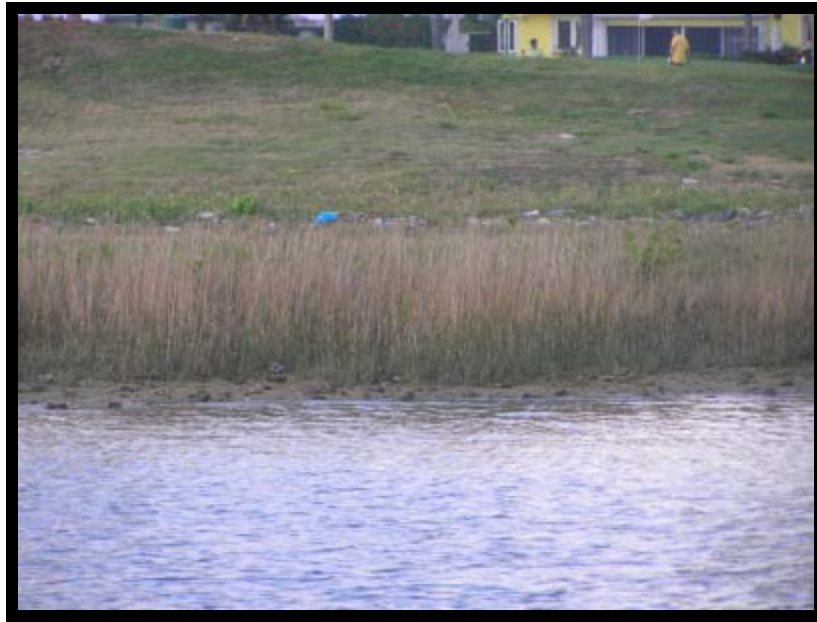
6421 Cordgrass *Spartina*

This community of non-woody, salt-tolerant plants occupying intertidal zones that are at least occasionally inundated with salt water. They exist at the interface of land and marine waters, wherever wave energy is sufficiently low to allow their development and where mangrove trees are not dense enough to shade out the characteristic vegetation. This class will be mapped if *Spartina* occupies 66 percent of the community.

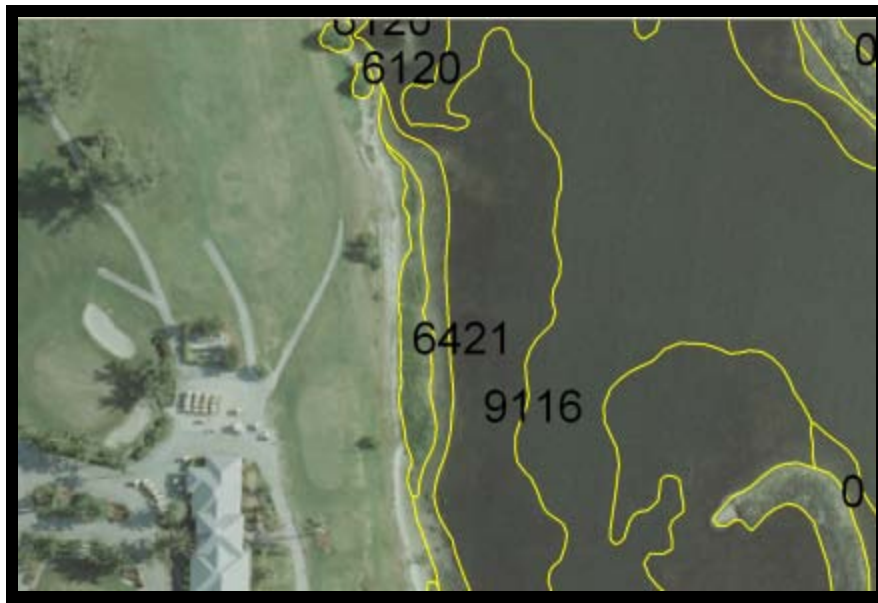
Delineated photograph showing 6421

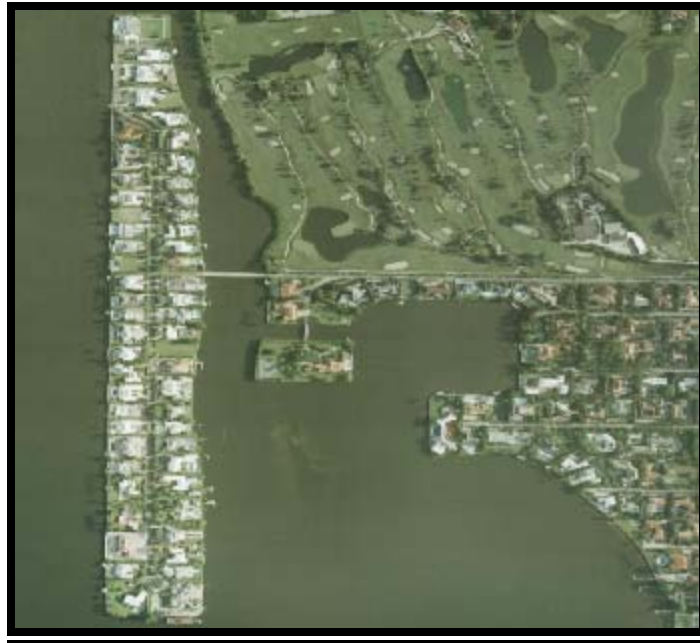
0 Not Classified (Land, islands etc)

Land for the 2007 Habitat Project will be considered all covertypes that are not included within the other classification types.

Mainland, islands and other land normally above the high tide line are also considered Land. The line delineating the water/land interface may be formed anywhere between the extreme low and extreme high tide marks.

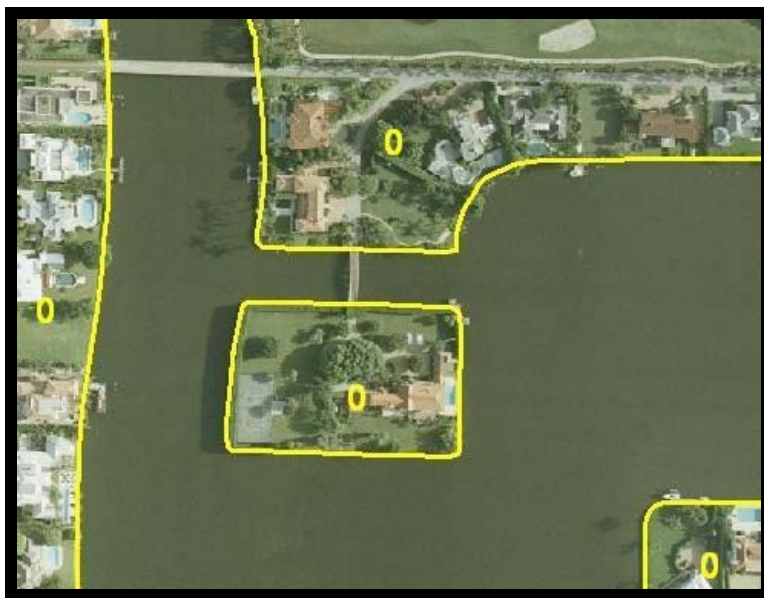
Delineated photograph showing 0 Not Classified (Land, islands etc)

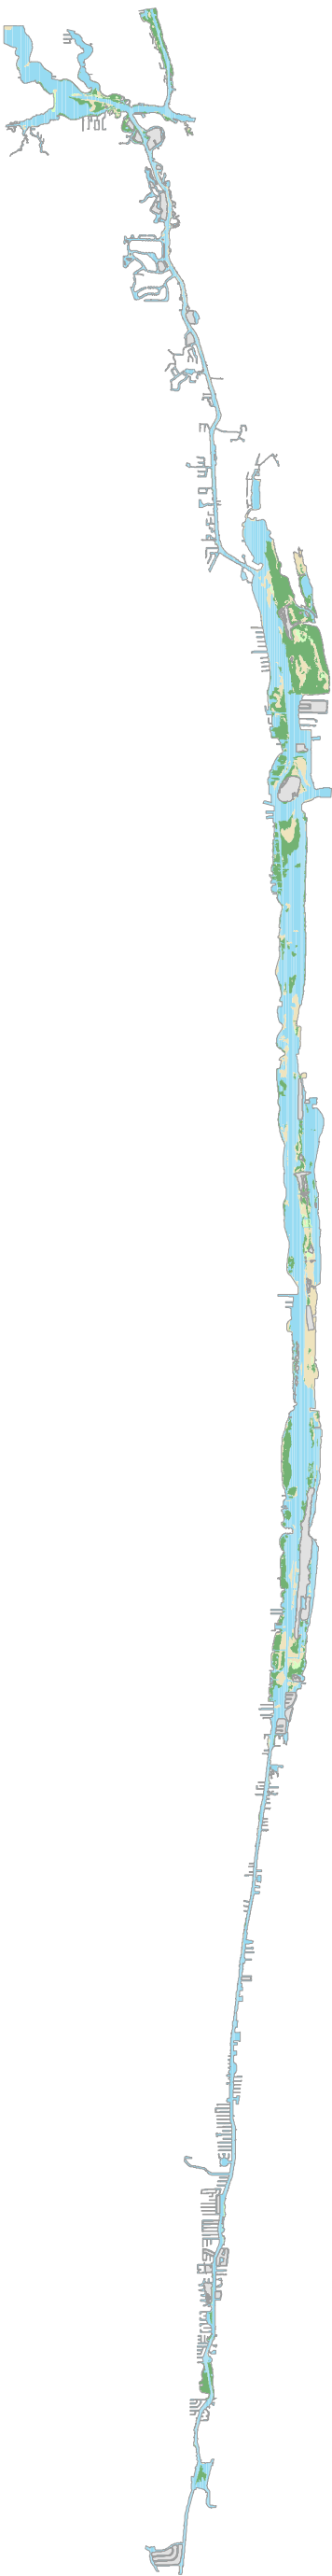
2007 Palm Beach County Submerged Habitat

Photointerpreted from 1:10000 and 1:4800 natural color aerial photography.
All habitat data was stereoscopically collected using photogrammetric techniques.
Photo Date:
2007 era photo dates: June, July and August of 2007

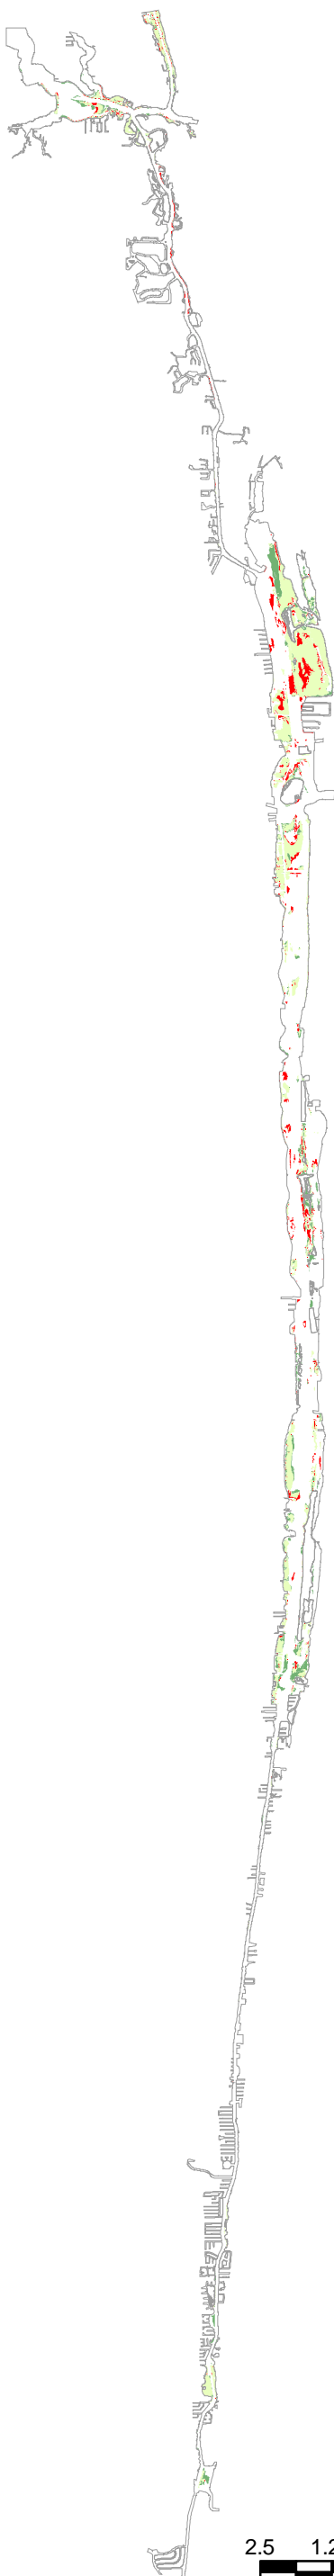
2001 To 2007 Change in Seagrass Distribution

Gain in Acres	Change
Gain	61.81	(3.13%)
Loss		
No Change

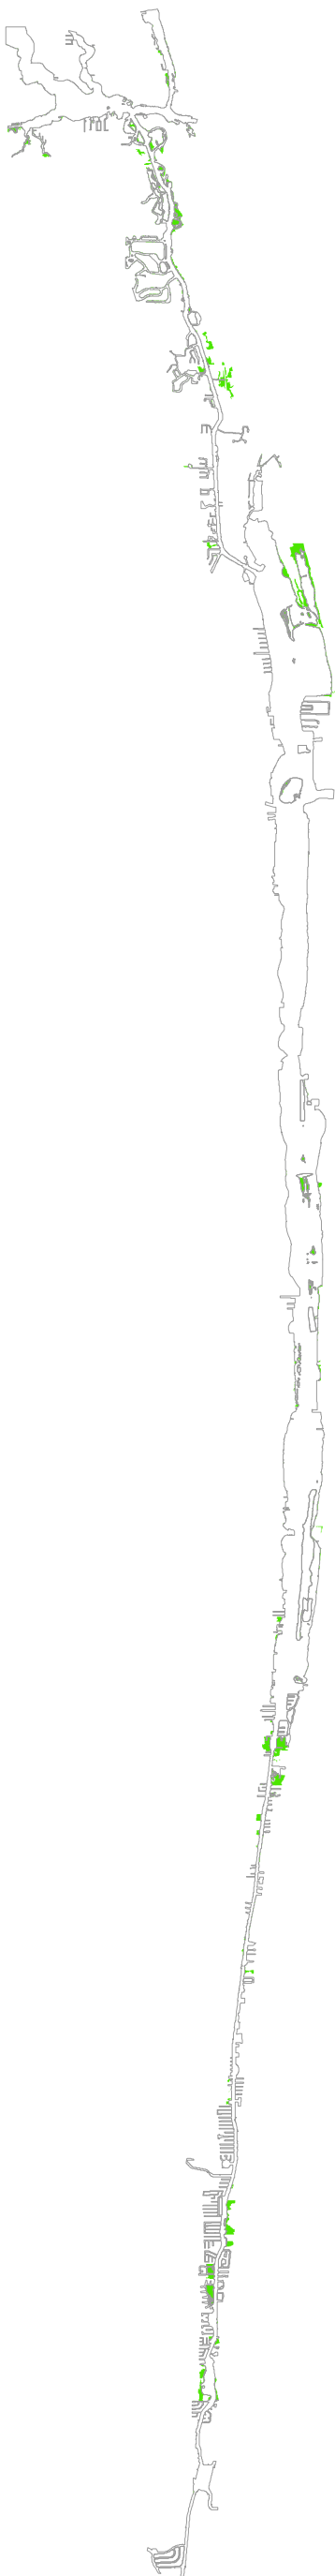
2007 Mangrove Habitat

Photointerpreted from 1:10000 and 1:4800 natural color aerial photography. Mangrove habitat data was stereoscopically collected using photogrammetric techniques. Photo Date: 2007 era photo dates: June, July and August of 2007

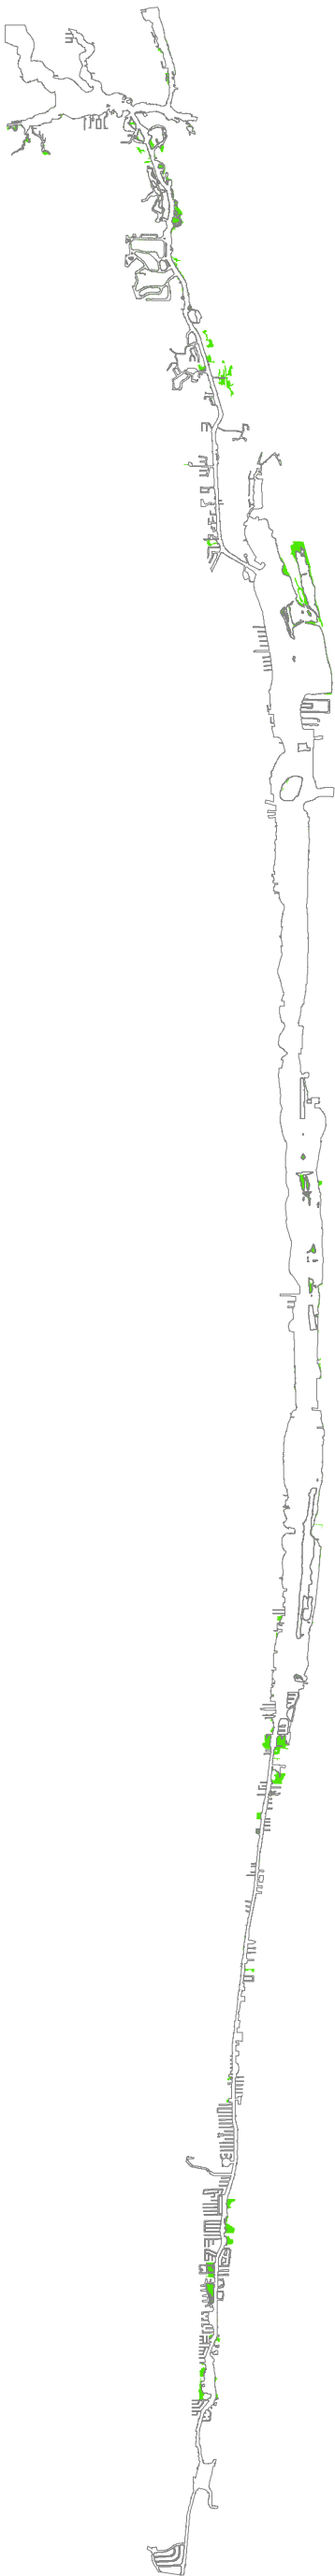
2001 Mangrove Habitat

Photointerpreted from 1:10000 and 1:4800 natural color aerial photography. Mangrove habitat data was stereoscopically collected using photogrammetric techniques. Photo Date: 2001 era photo dates: May, June and July of 2001

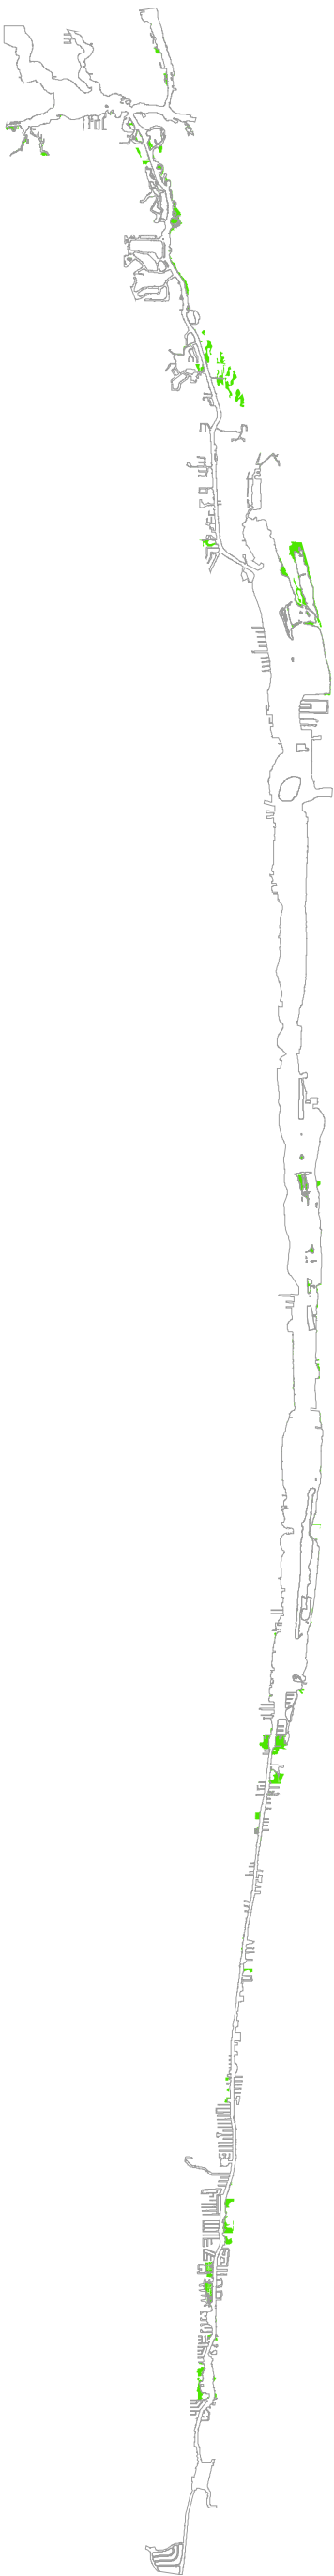
1985 Mangrove Habitat

Photointerpreted from 1:58000 CIR
All mangrove data was stereoscopically collected using photogrammetric techniques.
Photo Dates:
1985 era photo dates: Spring of 1985
