Living Shorelines along the Georgia Coast

A summary report of the first Living Shoreline projects in Georgia

Living Shoreline Summary Report

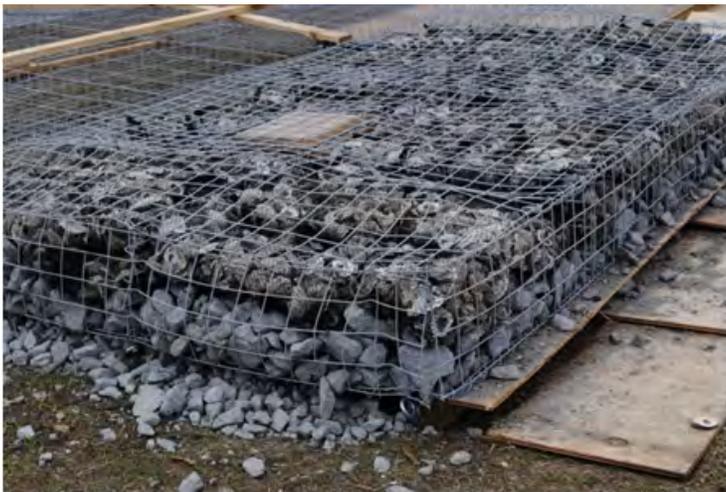
Figure 1. Gabion basket filled with granite and a bagged shell laminate.

The specified renomattresses were constructed of welded steel wire, and measured 6' wide by 12' long by 1' thick (figure 1). Each mattress was to be placed vertically on the embankment and secured with a square shaft metal anchor with a 6" plate to a depth of 10' (figure 2). The renomattresses were recommended by the engineering firm because the slope of the embankment was thought to be too steep for oyster bags. Renomattresses are conventionally considered a hard-arming technique,

however, three types of materials were prescribed by the project team as fill-material in the interest of promoting oyster growth and habitat: 1) bagged oyster shells on top of granite rocks, 2) loose oyster shells on top of granite rocks, and 3) granite rocks only. Three types of fill-material were also prescribed in the interest of experimentally determining which material serves as a more effective growth medium for oysters.

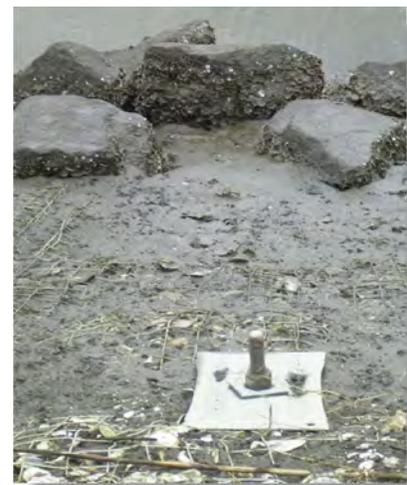
Figure 2. Gabion with anchor and rock toe.

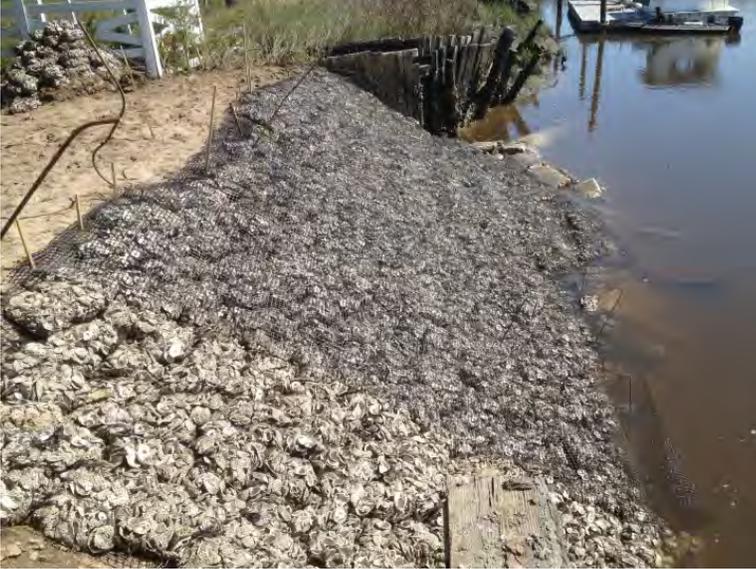
*Bottom course of oyster bags wrapped in geogrid.
Little St. Simons Island, GA*

Recycled concrete was used at the toe of the slope in order to reduce the transportation and ecological costs associated with the granite stones. The oyster bags were to be placed along the bank from -4' below mean tide elevation at the bottom the bank to 4.5' above mean tide elevation at the top of bank. The upper elevation of the oysters bags on LSSI was designed to be 0.5' higher than on Sapelo in order to better protect the top of bank from erosion associated with high tides and storm water runoff. Plans for native plants were much more extensive at the top of bank than they were at Sapelo Island due to funding availability and included some areas in the intertidal zones as well.

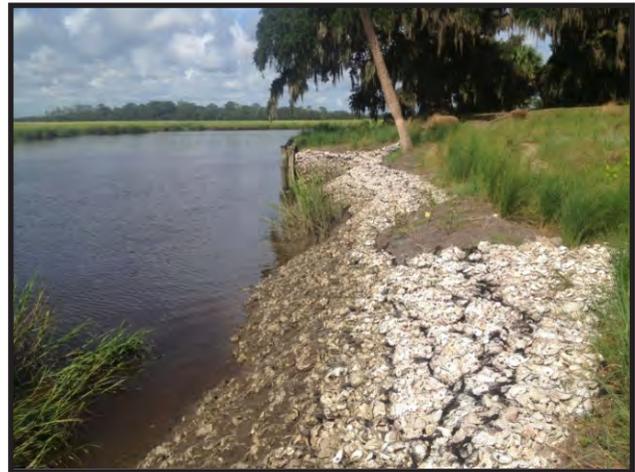
Little St. Simons Island shoreline progress 2012 (left) and 2013 (right)

Minor erosion occurred at the top of bank at LSSI, as it did at the Sapelo sites, due to rain and storm water runoff, but it was not extensive and was easily repaired. Additional oyster bags, soil, and erosion control blankets were placed and monitoring will continue. The potential for erosion of these areas should be eliminated as native plants and their root systems become more established. The plans specified the placement of bags up to 4.5' above mean tide on LSSI, which is 0.5' higher than the top of bags at Sapelo, but did not extend further in consideration of the planting designs. In future projects, oyster bags (or approved alternative) should be placed higher on the embankment and then covered with soils and plants and erosion control blankets as required. The additional bags, while ineffective as cultch material and invisible, would eliminate the potential for extensive gullies which could compromise the integrity of the bank from within.

Native plants, such as *Spartina alterniflora*, were successfully planted on middle and upper portions of the embankment. The embankment soils in these areas have not eroded, but will need to be monitored to confirm persistence and sufficiency over time. This method is not recommended for areas with high tidal velocities, such as those at the Ashantilly site.

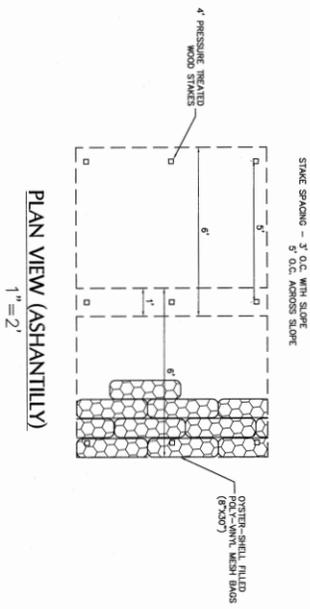
Ashantilly Construction Detail

SECTION B-B (ASHANTILLY)
1" = 2'
