Is Water Quality Suitable for Oyster Reef Development in Naples Bay? A Reef Restoration Demonstration Project

Michael Savarese¹, Lesli Haynes¹, Erin Dykes², and Aswani K. Volety¹

¹ Florida Gulf Coast University

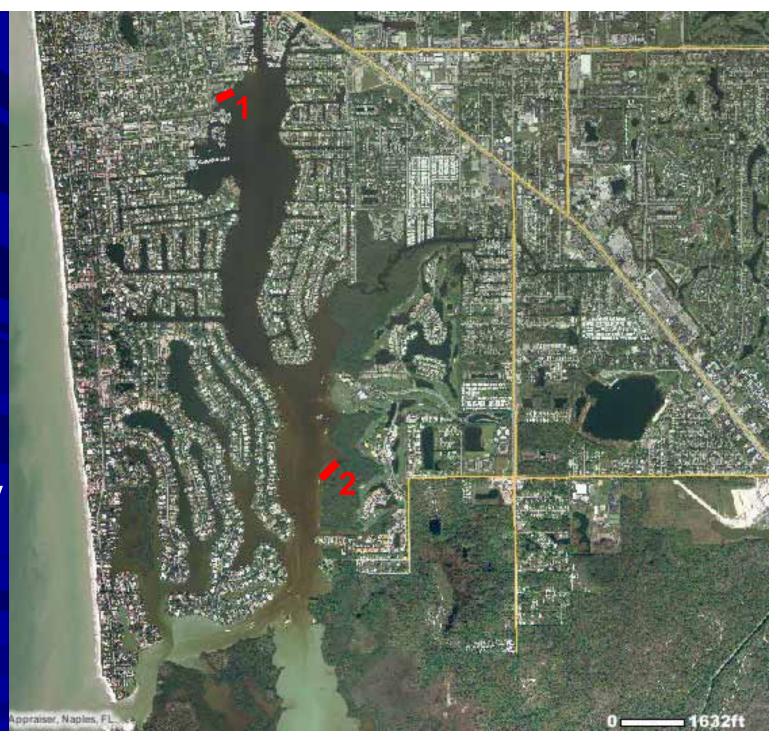
Reef Localities

1 Naples Landing

2 South Bay

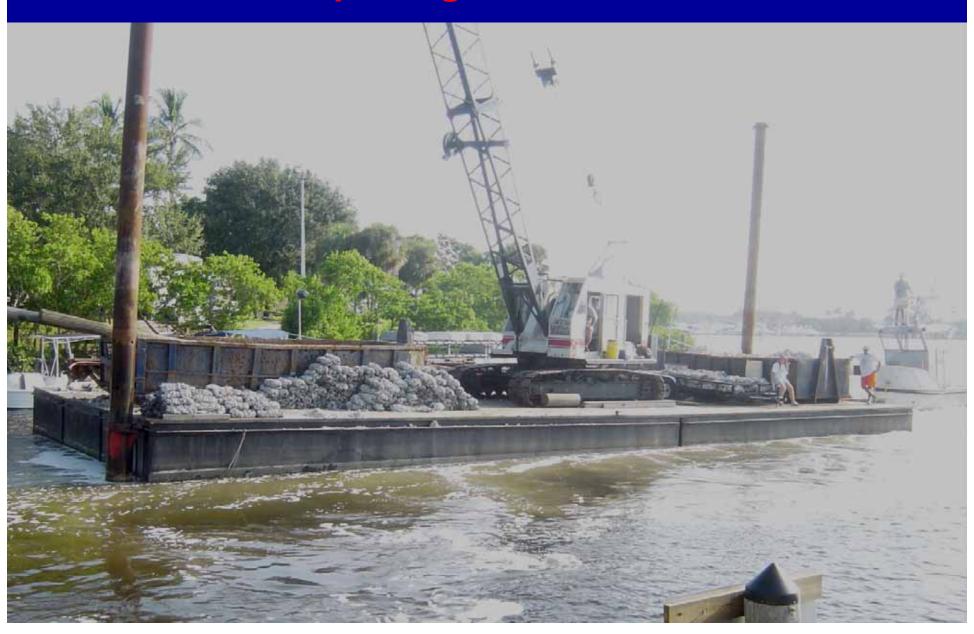
Building the Substrate Transporting loaves to site

- Use of shell cultch & shell loaves.
- Conducted on Sept 17, 2005. Postponed because of Hurricane Katrina.
- 50 volunteers, 4 boats, 400 bags of oyster cultch.
- Volunteers from: FGCU, City of Naples, Rookery Bay NERR, Mariner High School, Twin Eagles Golf Club, and Naples Dock & Marine.
