Lassing Park

Oyster Reef and Seagrass
mitigation project for Homeland
Security

SEAGRASS & OYSTER REEF PROJECT

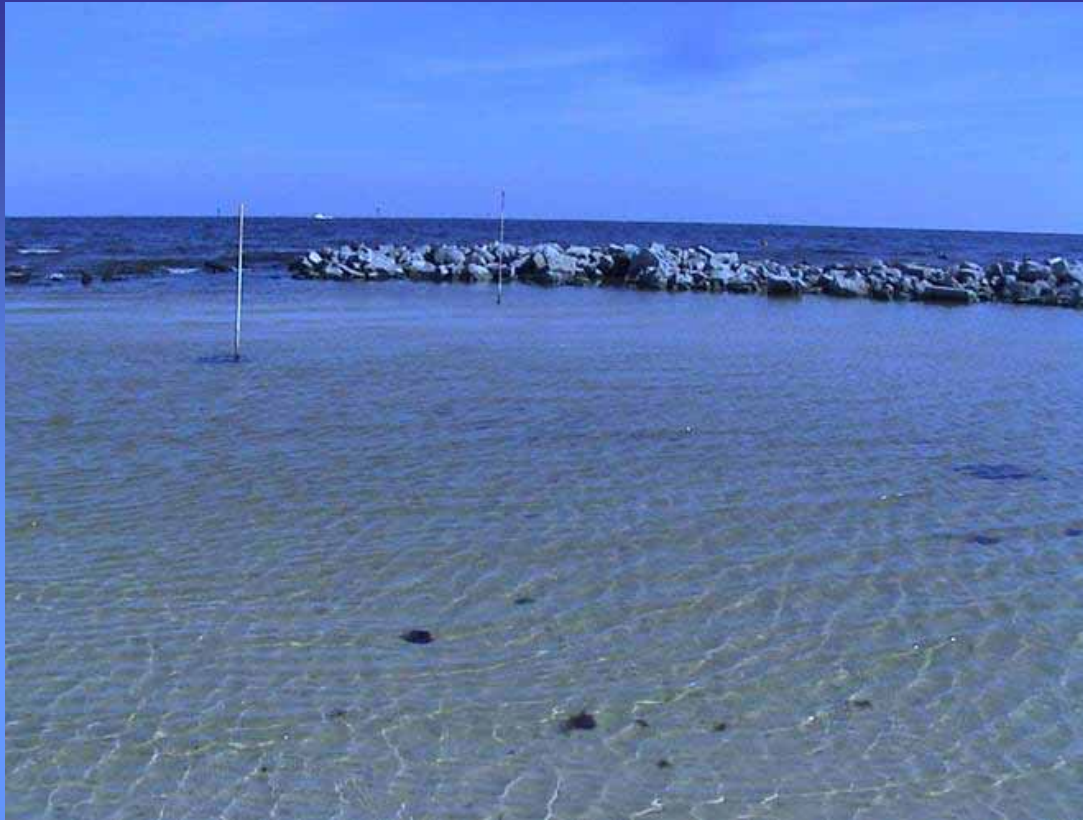
- Concrete rubble deployed in December 2002
- Rubble was from the boat ramp at the Coast Guard base
- Concrete was not broken into small enough pieces
- Design was altered by JJ Sosa

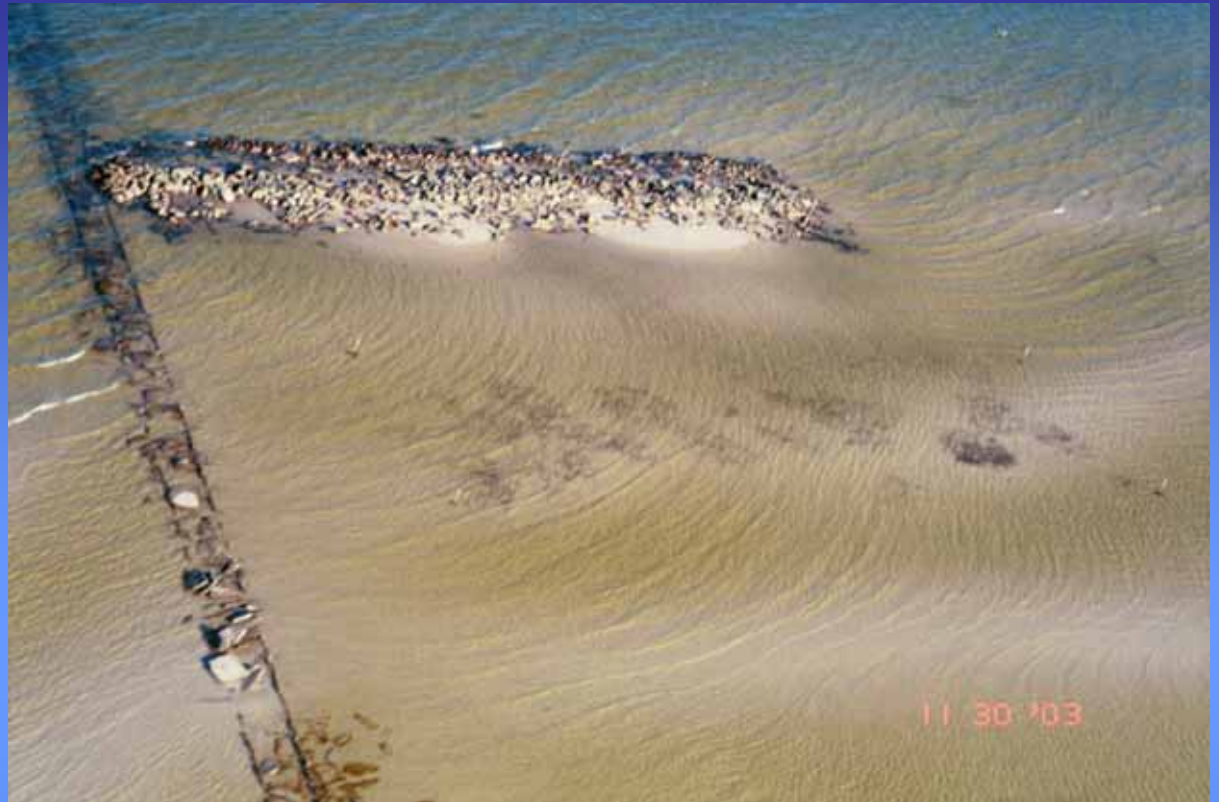
- Concrete rubble 1 year after installation
- Sand buildup west side
- Constant pounding from winds and wave action
- No oyster colonization

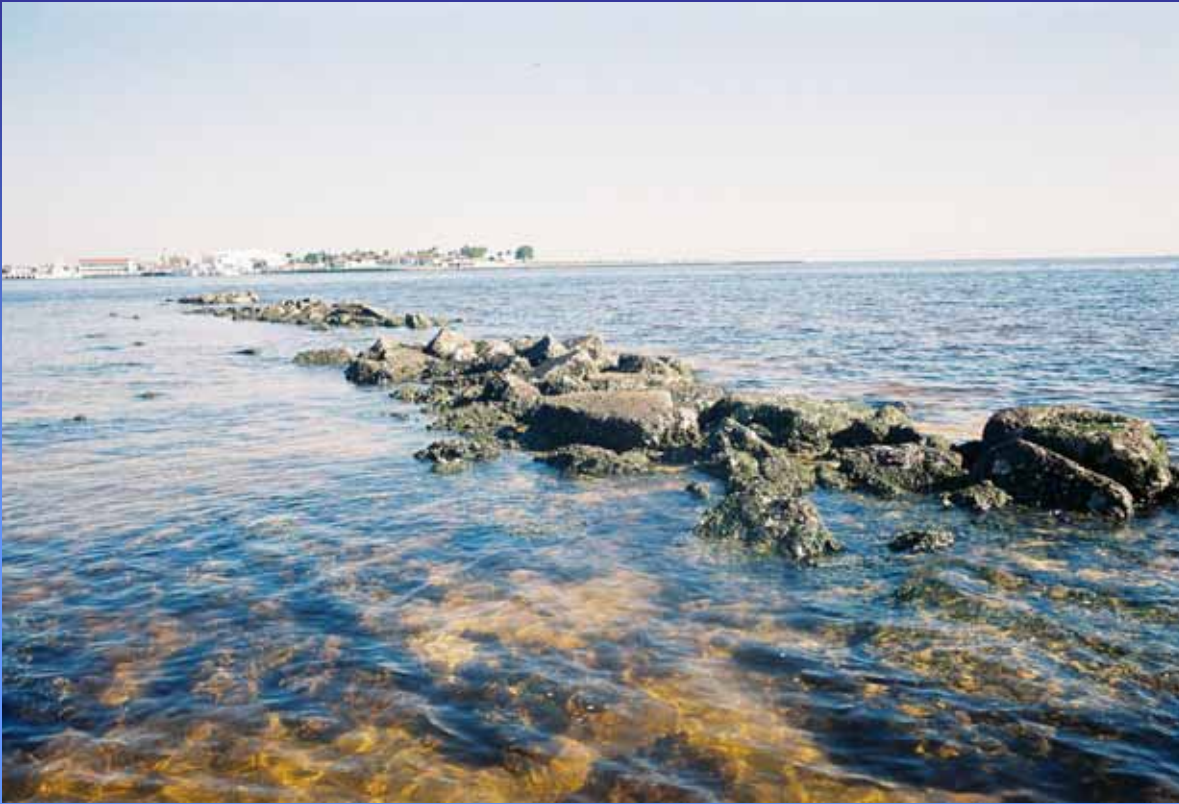
- Crustaceans starting to become heavily colonized on the east side
- Less colonization on the west side
- Beginning of noticeable oyster colonization

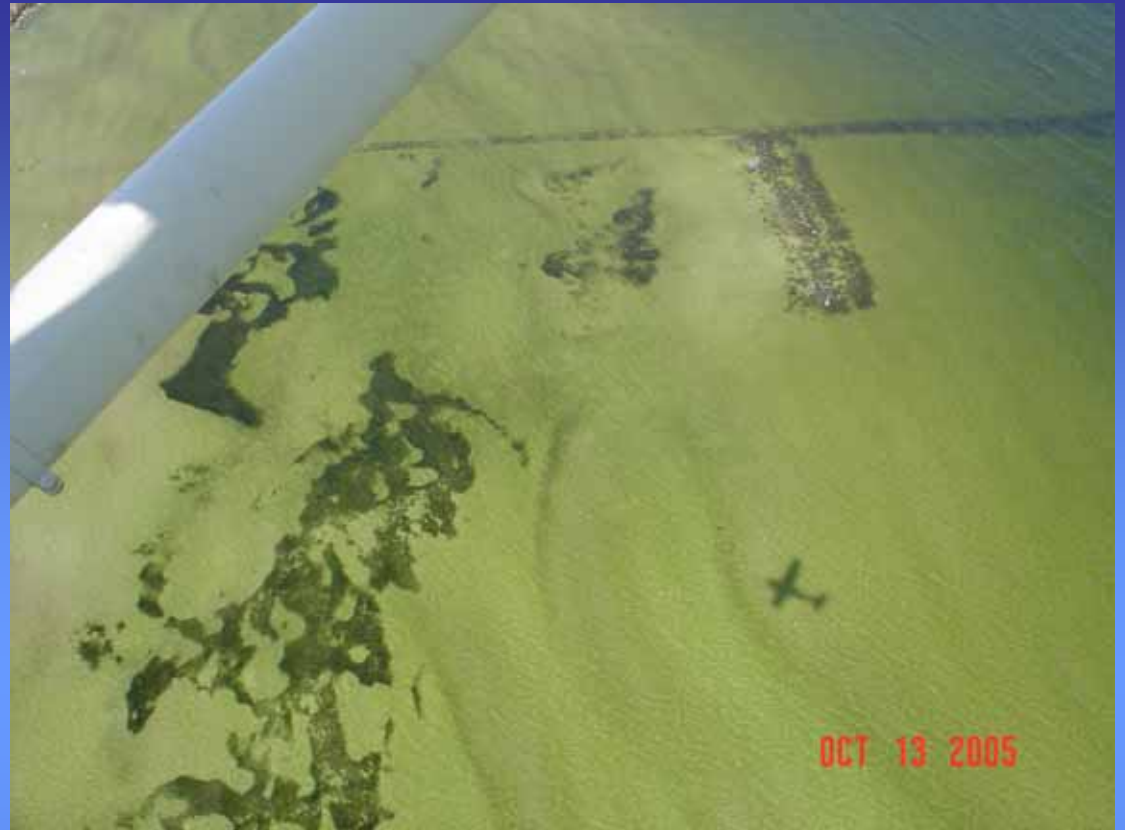
- Breakwater continues to grow further to the east
- Sand is accumulating on the east side
- Seagrasses are growing at a faster rate

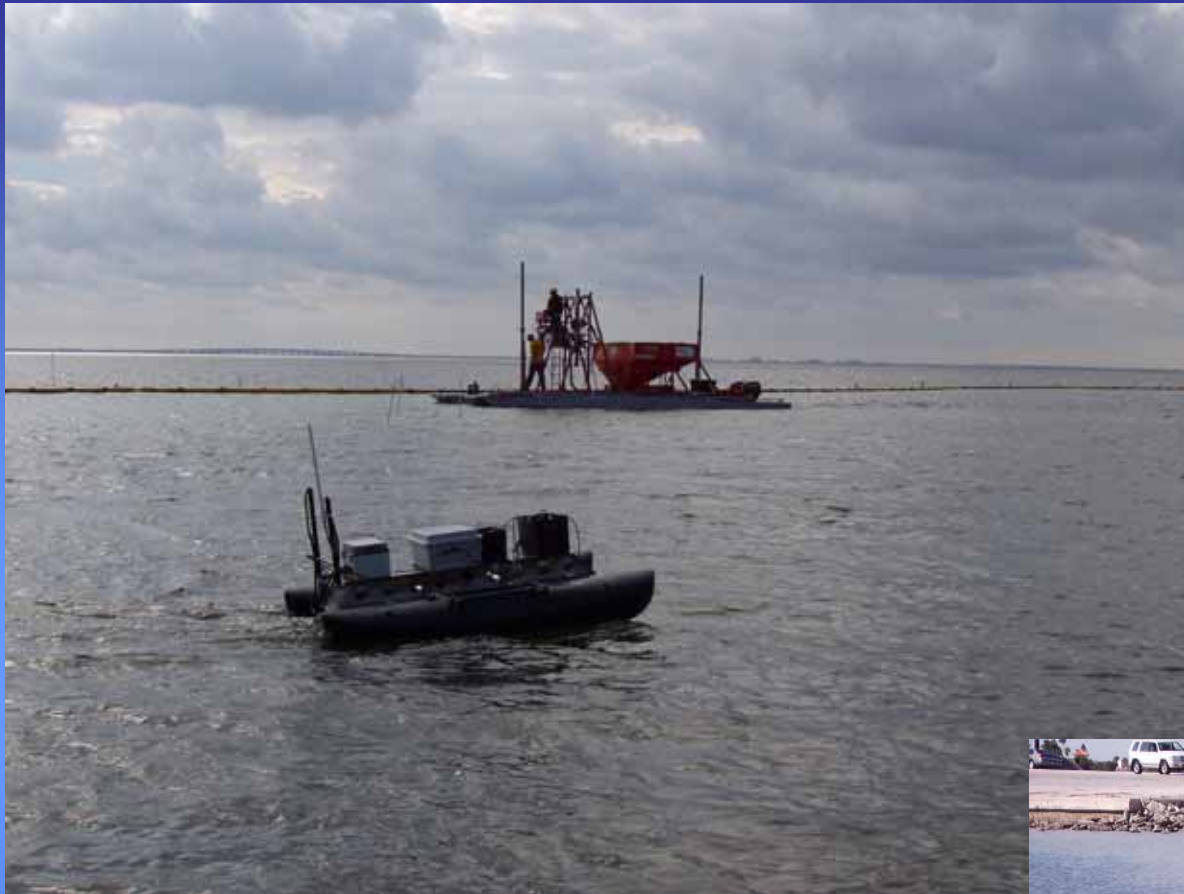
**Unmanned Monitoring
Vessel equipped with video
and GPS data**
